Technical Bulletin

Effects of Artificial Drying of the Cement

TB#: RTTNA-003-TB Rev. # 1

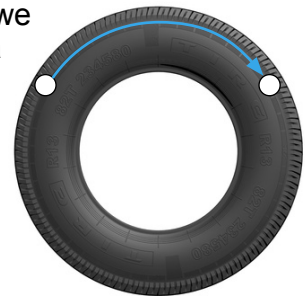
Fig 1

To aid in the complete drying of the cement after application, we recommend that the tire be rotated to locate the cemented area between the 10:00 o'clock and 2:00 o'clock position (see Fig. 1). By doing so, the gases from the cement will fall to the bottom of the tire, away from the cemented repair area. This will prevent any build-up of residual gas in the buffed tire surface.
